Manhole Inspection Summary

Manhole # S43II_051MH

Insp Date: **7/2/09 8:42 AM**

Location Address: **INTER FEDERAL ST**

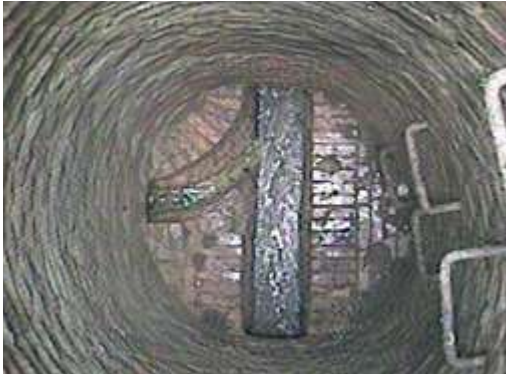
Defect 2

Count: **8** Missing: **1** ☒ **Corroded**

STEPS CORRODED

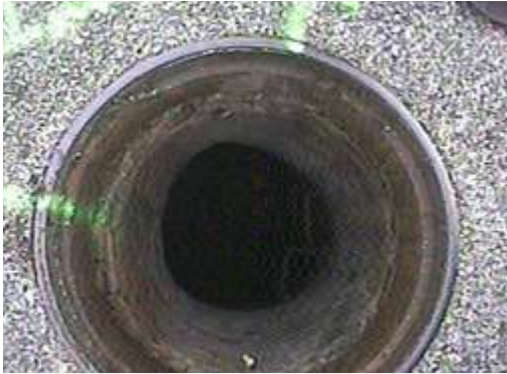
Defect 1

Offset: **1** (in.)

FRAME OFFSET

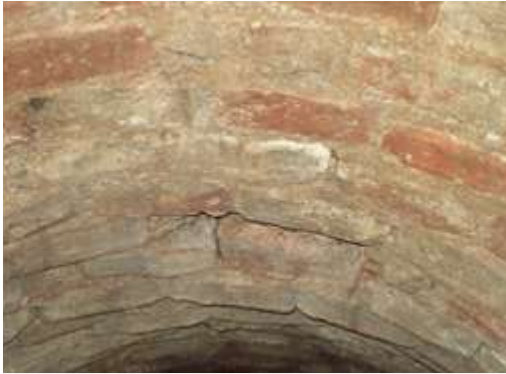
Defect 3

Condition: ☐ Sound ☒ **Cracked** ☐ Root Intrusion ☐ Loose Brick ☒ **Deteriorated**

CRACKED AND DETERIATED CORBEL
